Manhole Inspection Summary

Manhole # S09OO_036MH

Location Address: **2400 DENISON AVE**

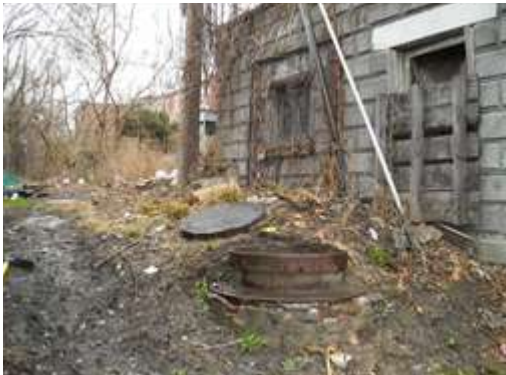
Location View

BELOW AND ABOVE GRADE - IN HILLSIDE

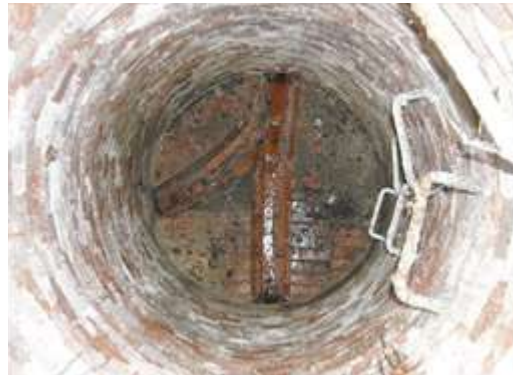
Top View

SHEETING

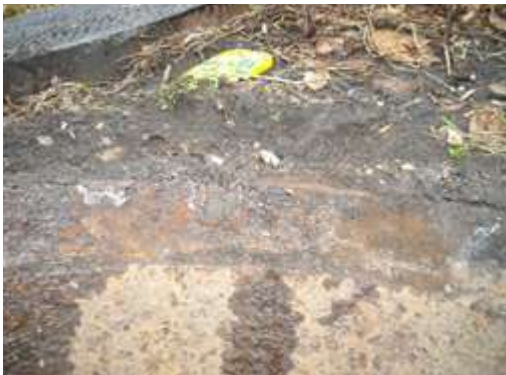
Defect 2

Subject To Ponding: **Sheeting**

EVIDENCE OF INFILTRATION DUE TO SHEETING - BACK SIDE OF FRAME IS BELOW GRADE

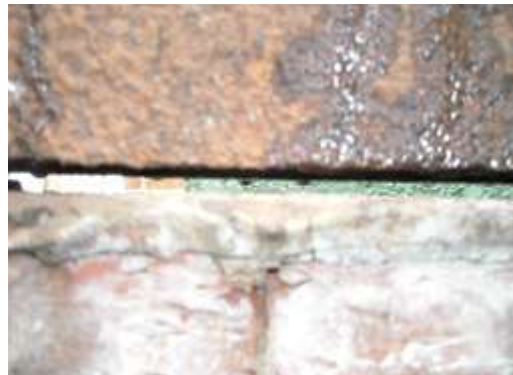
Defect 1

Frame Offset: **0** (in.) Condition: ☐ Sound ☐ Cracked ☒ **Leaks**

FRAME LEAKS

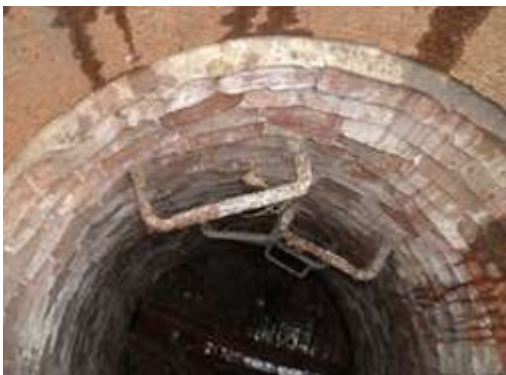
Condition: ☐ Sound ☐ Cracked ☐ Root Intrusion ☐ Loose Brick ☒ **Deteriorated**

Steps Count: **6** Missing: **0** ☒ **Corroded**

Surcharge ☒ **Evidence Of Surcharge** Depth: **2** (ft.) ☐ Active Surcharge Present

deteriorated corbel; corroded step and evidence surcharge

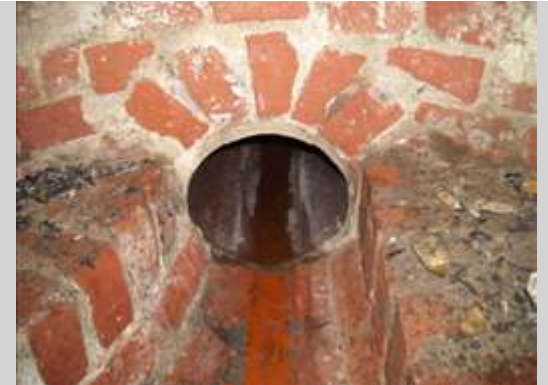
12 O'Clock Outflow

8 in. Circular Gravity Sewer
Pipe Out @ 12 O'Clock

Pipe Height: **8.4** (in.) Rod and Bar (Angled)
Pipe Material: **Clay** ☐ Pipe Lined
Invert Depth: **10.25** (ft.) Flow Characteristics: **Slow**
Deposits: ☒ None ☐ Mud ☐ Sludge ☐ Debris ☐ Grease
Silt Depth: (in.) Deposits Extent:
Infiltration: **None** Pipe Seal Cond: **Sound**

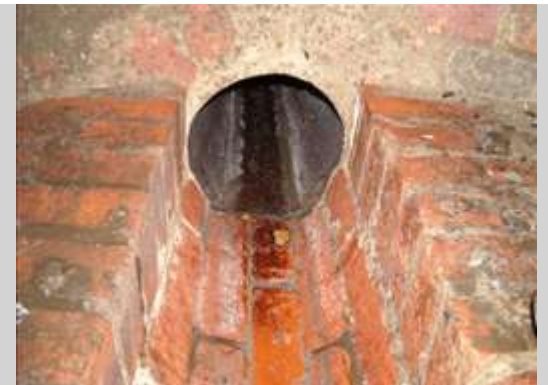
6 O'Clock Inflow

8 in. Circular Gravity Sewer
Pipe In @ 6 O'Clock

Pipe Height: **8.4** (in.) Rod and Bar (Angled)
Pipe Material: **Clay** ☐ Pipe Lined
Invert Depth: **9.83** (ft.) Flow Characteristics: **Slow**
Deposits: ☒ None ☐ Mud ☐ Sludge ☐ Debris ☐ Grease
Silt Depth: (in.) Deposits Extent:
Infiltration: **None** Pipe Seal Cond: **Sound**

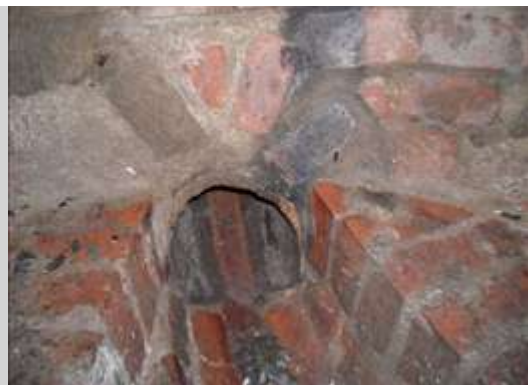
9 O'Clock Inflow

8 in. Circular Gravity Sewer

Pipe In @ 9 O'Clock

Invert Depth: **9.85** (ft.) Flow Characteristics: **None**
